STILLING BASIN PERFORMANCE STUDIES  
AN AID IN DETERMINING RIPRAP SIZES

Hydraulic Laboratory Report No. Hyd-409

Commissioner's Office--Denver  
Division of Engineering Laboratories  
Hydraulic Laboratory Branch  
Hydraulic Structures and Equipment Section  
Denver, Colorado  
February 23, 1956

Subject: Stilling basin performance studies--An aid in determining  
riprap sizes

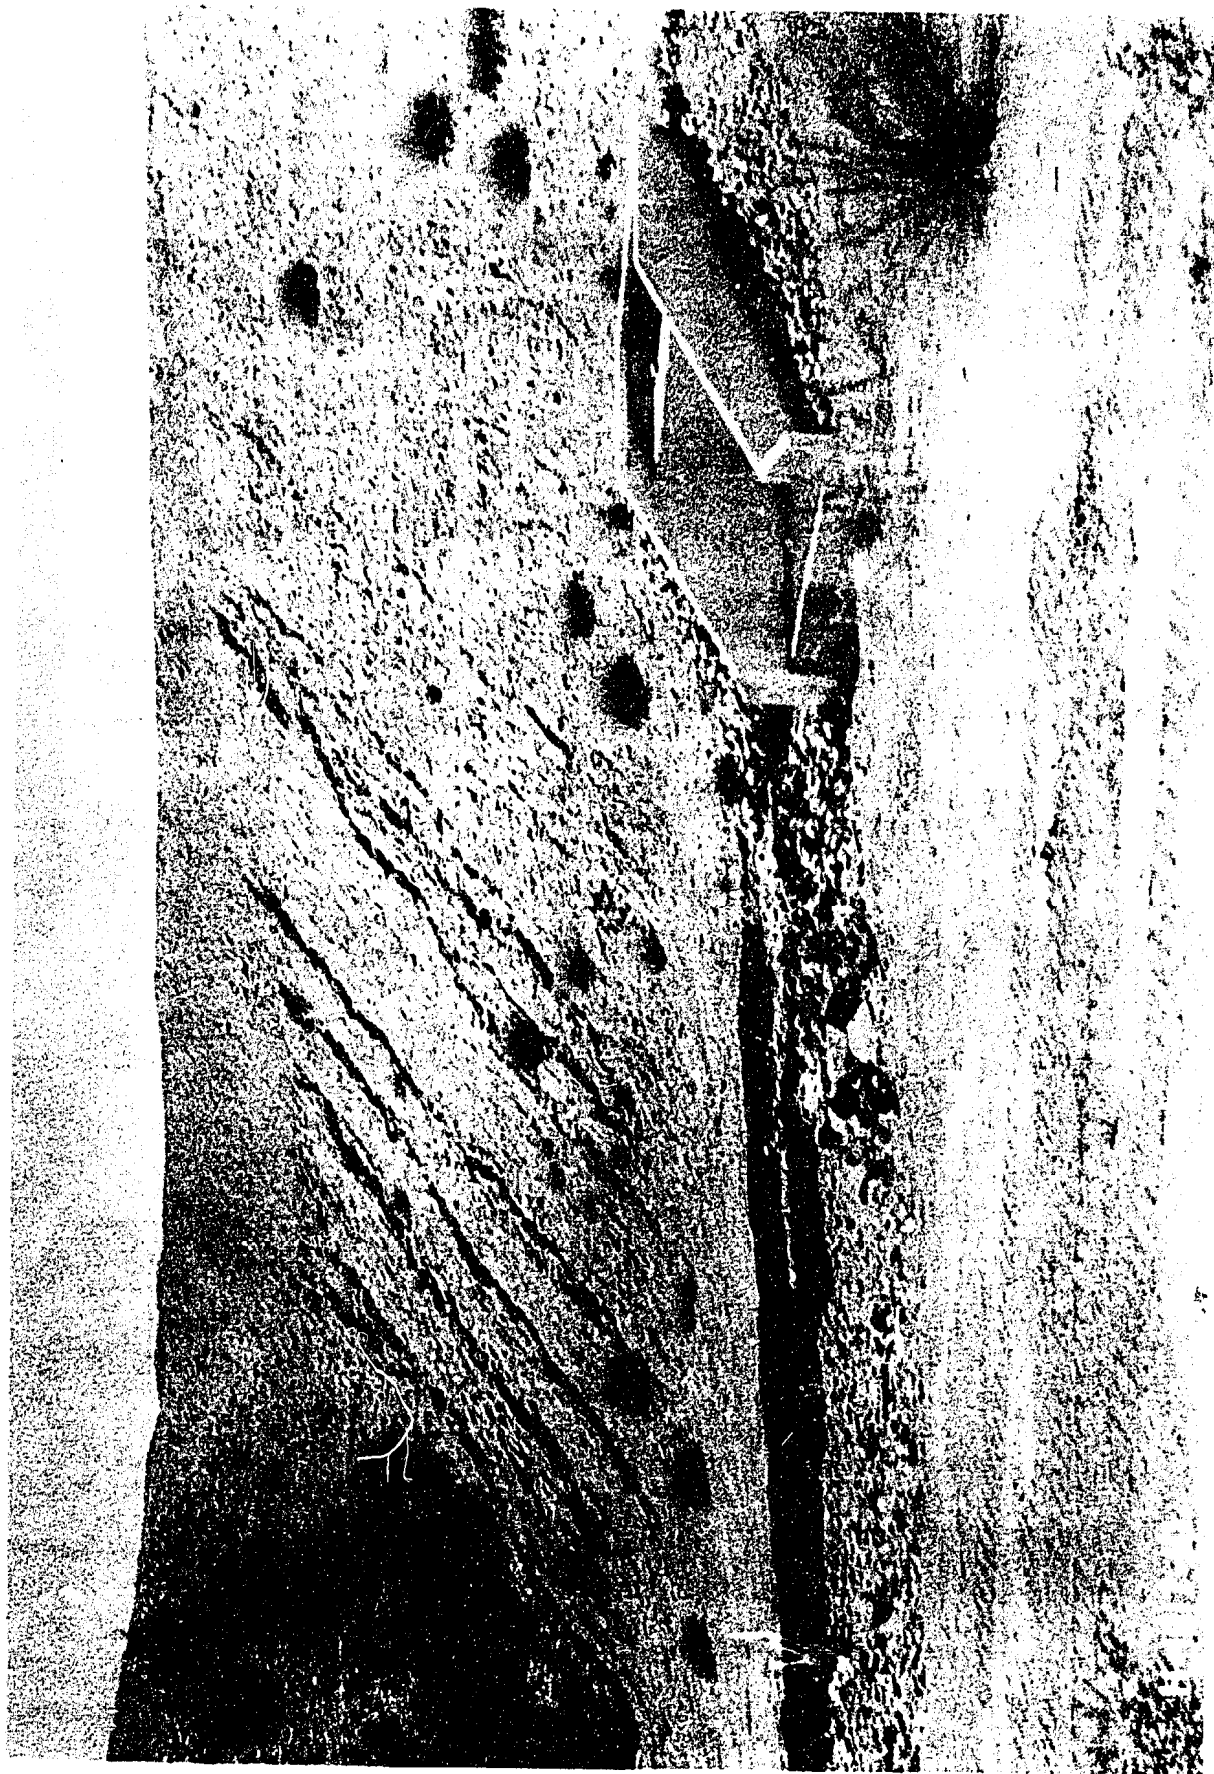
FIGURE 5

Impact-type stilling basin structure - following flood of  
August 20, 1954. North Branch Dam in background.

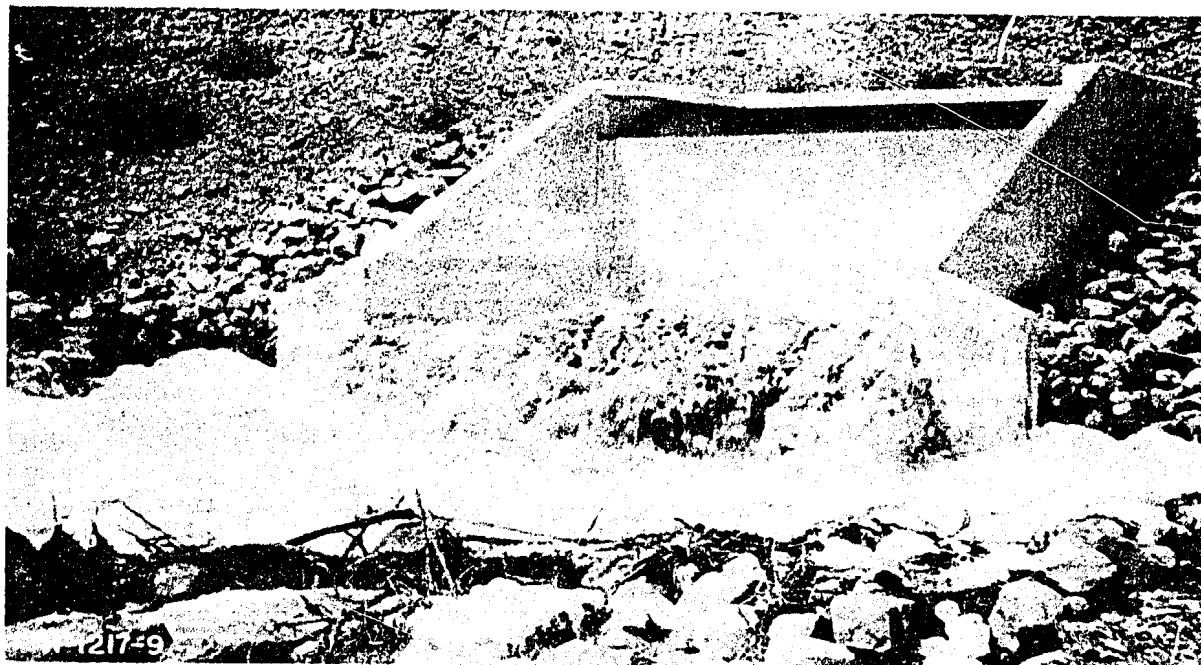
FIGURE 6

It should be noted in Figure 6 that the tail water is low with respect to the stilling basin. Therefore, the velocity over the end sill is considerably lower than the velocity striking the riprap. For the North Dam basin having a sill length of 15.5 feet, a critical depth of 1.5 feet over the end sill and a discharge of 210 second-feet, the critical velocity would be 7.6 feet per second, requiring riprap, Figure 11, about 9 inches in diameter. Further acceleration of the flow by a drop from the end sill to the tail water surface of 2 feet, Figure 6, would result in a velocity of about 14 feet per second, requiring riprap about 30 inches in diameter. Thus, the importance of matching the basin elevation to the probable tail water elevation is evident. In the case of the North Dam basin, however, the tail water elevation was, no doubt, higher before the riprap was lost.

North Branch Dam outlet works structure discharging  
210 second-feet (80 percent of maximum).

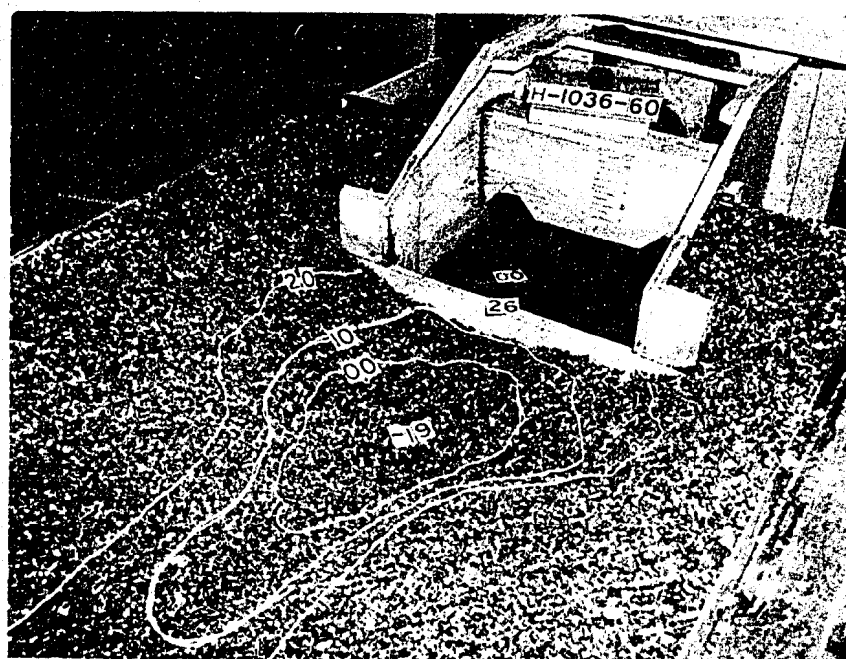
**Hydraulic model indicates erosion similar to prototype when rip-rap size is inadequate.**

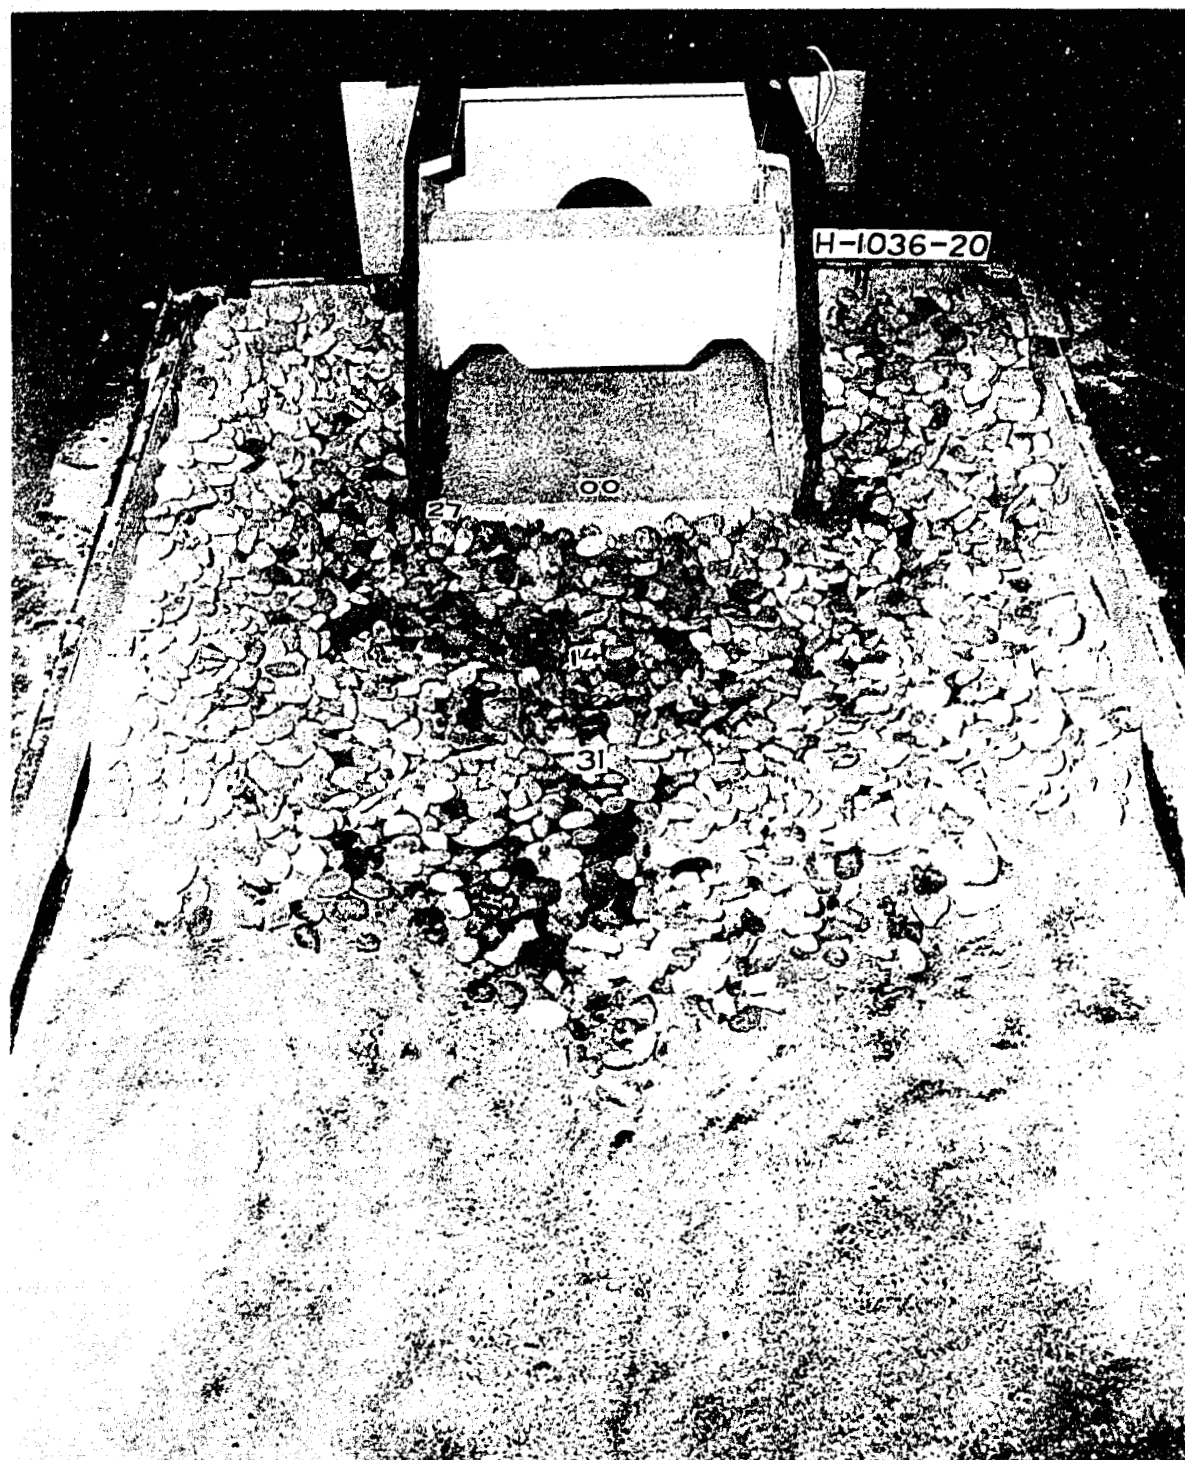
FIGURE 10

According to Specifications No. DC-3856 the riprap below the outlet " \* \* \* shall consist of durable rock fragments reasonably graded in size \* \* \*" from 1/8 cubic yard to 1/10 cubic foot. The individual rocks, therefore, would vary from about 18-inch cubes to 5-1/2-inch cubes, or in weight, from about 500 pounds to 15 pounds. Although it is impossible from the photograph of Figure 7 to determine the size of riprap in the channel at the start of the run, the bank riprap indicates that there were very few rock pieces of the 500-pound size. The few remaining pieces near the man at the right seem to be in the upper size range and apparently these did not move. In the hydraulic model tests made to develop this basin, riprap corresponding to 9- to 18-inch cubes did not show excessive movement of the rock mass, Figure 10, but did show some erosion downstream from the end sill.

Hydraulic model tests using 9 to 18 inch diameter (equivalent) stones shows some movement of riprap.
